IG1 RELAY

ON-VEHICLE INSPECTION

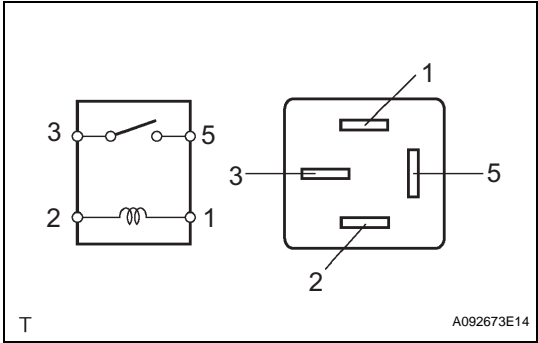
1. DISCONNECT CABLE FROM NEGATIVE BATTERY
TERMINAL
- CAUTION:
Wait at least 90 seconds after disconnecting the
cable from the negative (-) battery terminal to
prevent airbag and seat belt pretensioner activation.
2. REMOVE IG1 RELAY
- (a) Remove the IG1 relay from the instrument panel
junction block.
3. INSPECT IG1 RELAY
- (a) Measure the resistance of the IG1 relay.
- Standard resistance

Tester Connection	Specified Condition
3 - 5	10 kΩ or higher
3 - 5	Below 1 Ω (when battery voltage is applied to terminals 1 and 2)

If the result is not as specified, replace the relay.
